HEGGEL® Corr 210

October 2021

## CASE STUDY Refinery Assets Maintenance

**This case study is based on a project in a gas refinery in Middle East, focused on repairing the corrosion-damaged areas of the gas pipeline system in a slug catcher unit, specifically on the condensate equalizer line.**

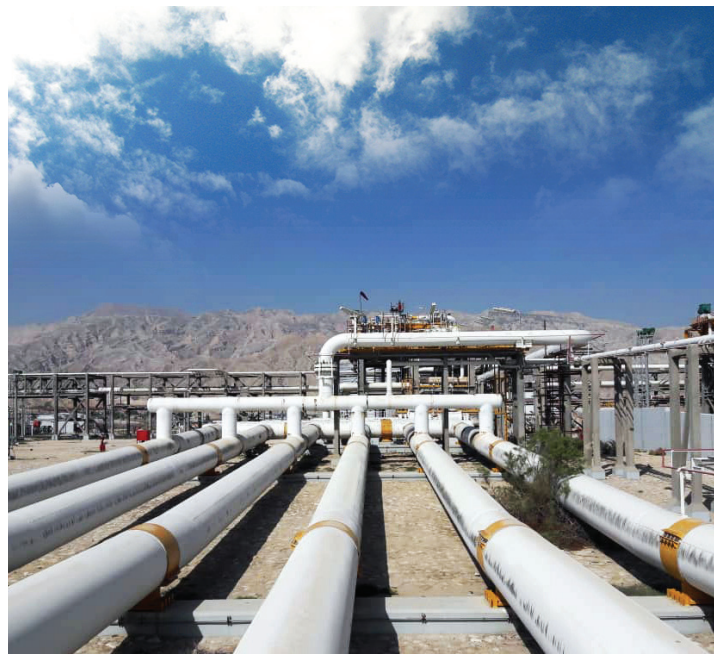
Inspection to determine the presence of any unforeseen pitting corrosion revealed a widespread issue with heavy corrosion along the pipeline and the 90-degree elbow on internal surfaces. Due to the H<sub>2</sub>S-containing Hydrocarbon Condensate at continued high operating pressure of 75 barg, corrosion was severely intensified to depth-extending pitting. Being 4 years in service, there were local metal loss areas shaped like isolated islands throughout the length of the pipe. Based on NDT inspection results, serious corrosion defects were detected at 6 o'clock position. More validations on external findings also showed that the most severe corrosion was confined to the bottom of the pipe where the wall loss was estimated as 10 mm creating a critical condition. Due to the subsequent integrity assessments, the slug catcher was not fit for continued operation at this excessive rate of pitting. Also, the remaining wall thickness was estimated at only 2.5 mm, justifying the decision to de-rate the system; since further corrosion could not be tolerated at the original design pressure of 139 bar.

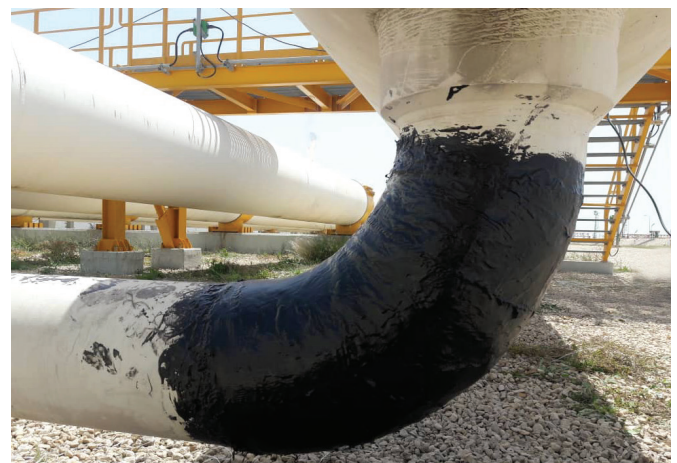
It is noteworthy to mention that not only the installation process of HEGGEL Corr 210 composite fully adhered to the highest safety standards, it was also performed within a very short time per customer's demand, taking into account that the unit should not be overhauled out of schedule. Based on results from later inspections, the applied HEGGEL Corr 210 system is in great condition and no deficiencies have been detected after several months.

After carrying out the surface preparation steps fully in compliance with HSE requirements on both application procedure and equipment, installation process was initiated by applying the first layer of HEGGEL Corr 210 thoroughly on the treated surfaces to approx. 1 mm thickness using spatula. Then the single layer of 300 gr/m<sup>2</sup> woven roving glass fiber was laid entirely in the coating, wrapping around the pipe. Afterwards HEGGEL Corr 210 was added to the surface with approx. 1 mm thickness and the embedded fiber was completely immersed in the coating.

After the installation of the first layers, it took nearly four hours for the combined system to semi-cure and be prepared for the next steps of the implementation process. To composite the next layers, the blasting operation was required to lightly roughen the semi-cured surface without removing a significant amount of the first applied coating to promote adhesion of the new layers. Here, light sweep blasting was continued until the adequate roughness was achieved and surface preparation standards were met. In order to get the protective system fully constructed with 6 coating layers, the first step of the installation process, i.e., the composition of Coating-Fiberglass-Coating, was re-performed two more times. Due to the temperature decrease during the night-shift operations, the drying time was increased up to 8 hours. Also, in order to have an optimized finishing, the gel coat thickness was increased to approx. 2 mm.
